**Permaquik 200**

Detail: Bug Holes or Voids

PQ-06

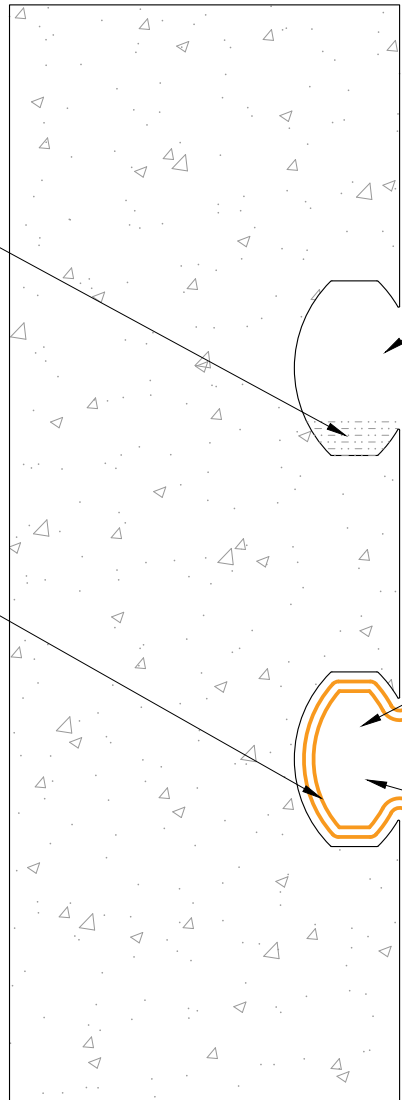
DEBRIS AND BACTERIA TRAP

UNTREATED BUG HOLE PRIOR TO WATERBLASTING

TRAP FILLED WITH PERMAQUIK 200

TREATED WITH PERMAQUIK 200 AFTER WATERBLASTING

NOTE: VISUALLY, PERMAQUIK 200 CAN BE SEEN ON THE INSIDE OF THE VOID. DEEPER VOIDS OR BUG HOLES MUST BE PATCHED. TEST AREA WITH 2 COATS OF PERMAQUIK 200 TO DETERMINE CRYSTALLINE INFILTRATION AND REPAIR AS NECESSARY. REPAIRS MAY BE DONE BEFORE OR AFTER PERMAQUIK 200 APPLICATION
